The Conservation of Wall Paintings in Tomb 35 at Dra Abu el-Naga

By GEOFFREY PEARCE

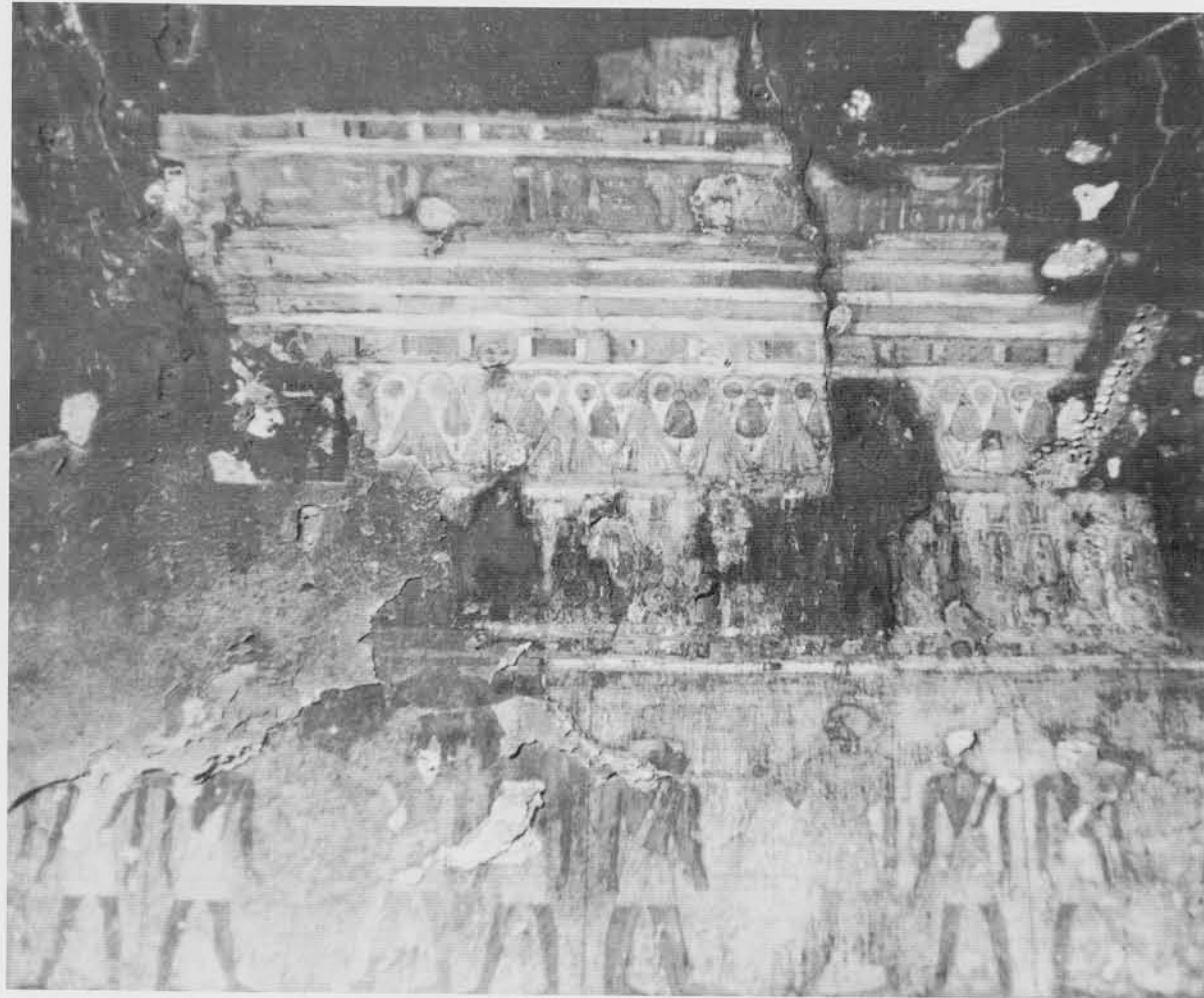
Wall and lower ceiling in broad-hall of tomb of the High Priest Bekenkhons (35).
 Decoration is revealed by removal of soot and dirt.

Finally it was discovered that a positive and rewarding result could be obtained by cleaning with a diluted solution of ammonia, applied lightly on cotton swabs, rolled gently to and fro across the decorated surface—rather than rubbing it—to minimize the shifting of pigments and damage to the underlying plaster supports. Repeated applications and frequent rinsing with fresh water produced a satisfactory result over an area of almost half of the antechamber of the tomb, being particularly rewarding in revealing polychromatic, hitherto unknown, figurative scenes on the vaulted ceiling.

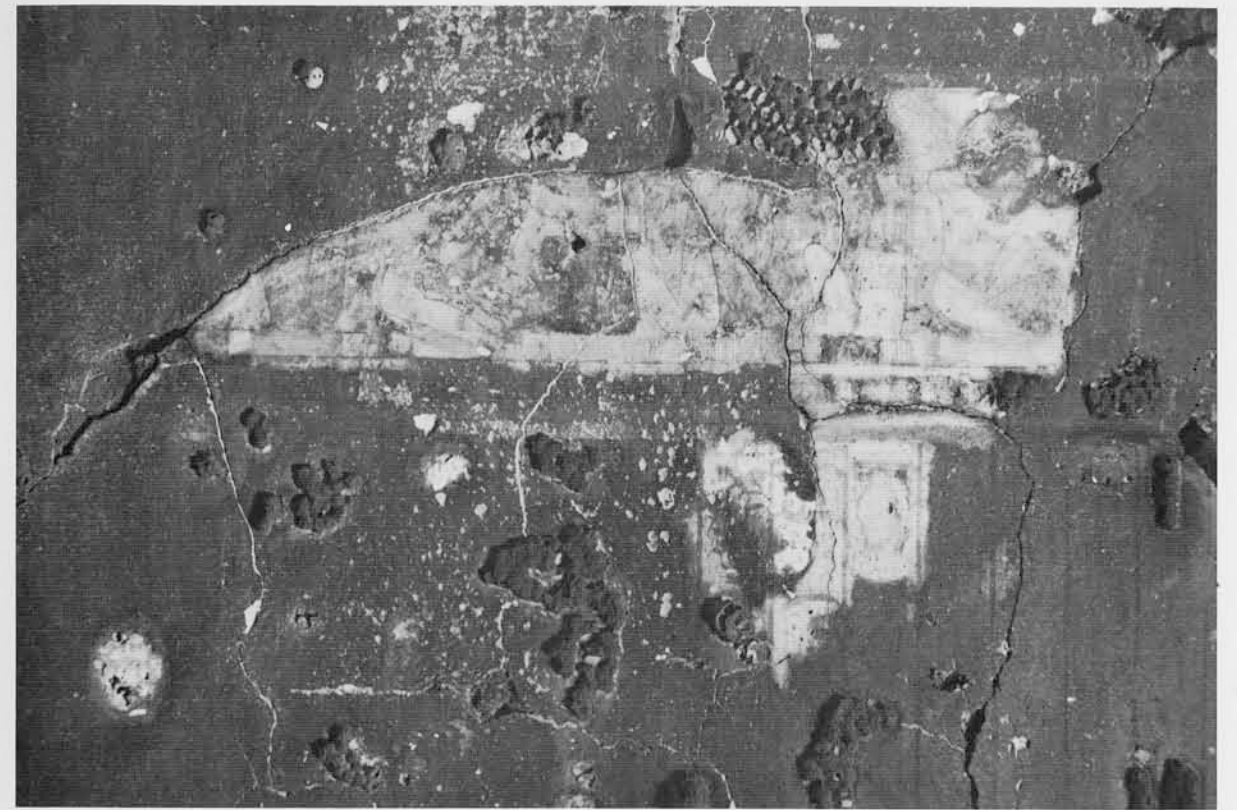
Vaulted ceiling in broad-hall of tomb of the High Priest Bekenkhons. Decorative motifs begin to emerge from beneath heavy deposits of soot and dirt. Extensive cracks due to shrinkage of plaster and its separation from the underlying limestone. Dark clusters are nests of mud-dauber wasps.

By the simple technique of infilling all cavities with mud, presumably collected from the banks of the Nile, the uneven surface of the limestone was rendered acceptably level for the application of the final coat of mortar. This undercoating, applied very wet and (presumably) without consideration of the extreme temperatures encountered in Upper Egypt, must have dried out too quickly (apart from being an unsuitable building material at the outset), and in many areas of the tomb, especially the vaulting, has shrunk. The effect of this shrinkage has been a separation from the structural

supports and also a cracking of the lime and sand mortar which is the actual support of the paint surface.

Where extensive separation of the mortar from the limestone has occurred, to create a new bond it will be necessary to inject, by the use of syringes, a new mixture of mortar (or a synthetic resin) into the cavity thereby formed. In some cases consolidation must be undertaken first, to make the plaster capable of withstanding even the slight pressures associated with cleaning. In ex-

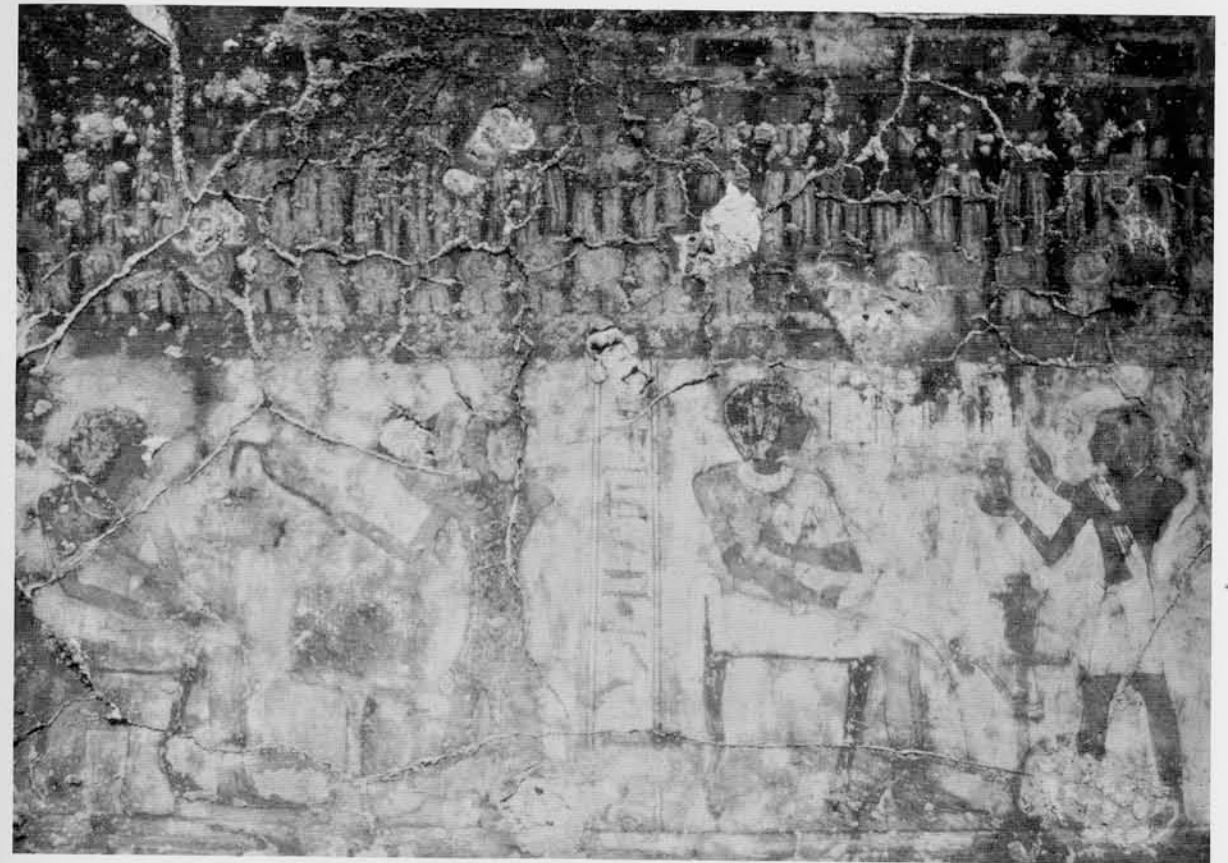
Two painted panels surmounted by a 'heker' frieze. From a series of newly discovered vignettes on the ceiling in the broad-hall of the tomb of the High Priest Bekenkhons.

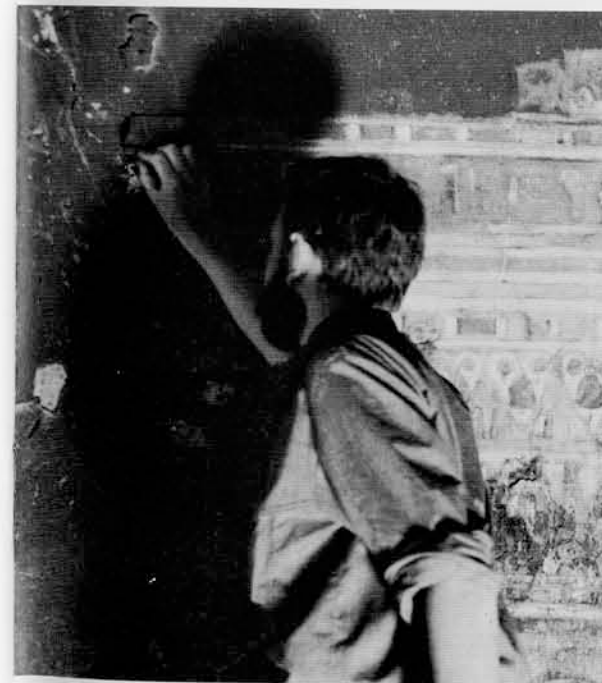
Removal of soot by manual cleaning of upper walls in broad-hall of tomb of Bekenkhons.

The removal of soot and smoke at present obscuring the decorative scheme was quickly found to be impossible with a mechanical method, *e.g.*, dusting or brushing (nor was the extensive use of putty rubbers entirely satisfactory), and so had to be tackled chemically with a solvent or solvents suitable for the safe removal of this particular kind of deposit.

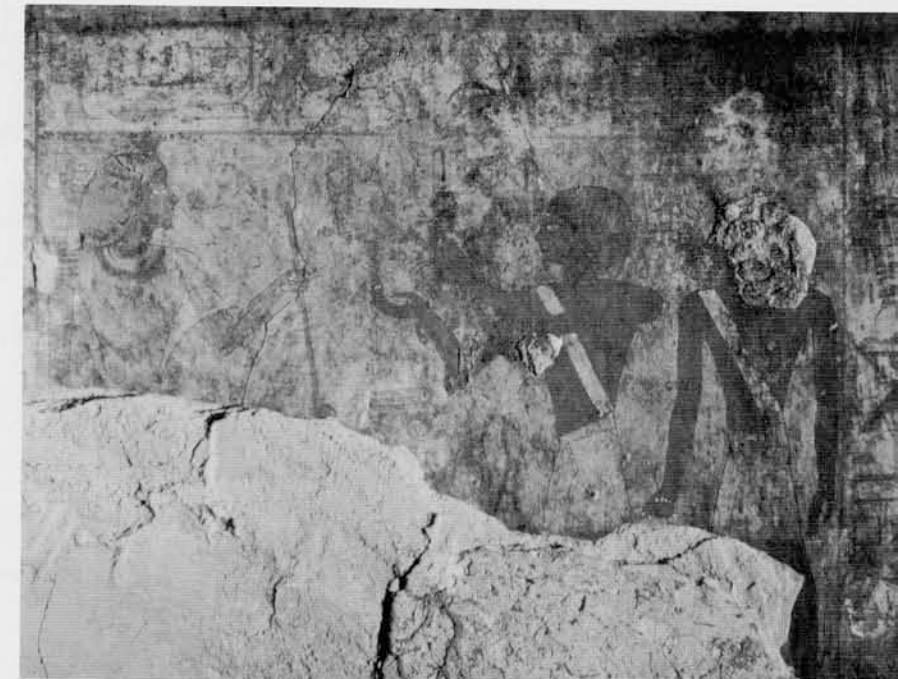
Damaged 'Opening of the Mouth' scene in broad-hall of tomb of the High Priest Bekenkhons, after partial cleaning. Discoloration due to physical and chemical decomposition of paint; head of figure on right obscured by nests of mud-dauber wasps. Below, surface plaster has fallen away, showing underlying fine, white lime plaster on left and thick, coarse mud plaster on right.

The removal of the nests built over several centuries by mud-dauber wasps (some indeed so ancient that they are as blackened by soot as their supporting plaster) proved to be a task as uncomfortable as it is complex. Preliminary tests showed that their removal by mechanical means was unsatisfactory; the nests with their cellular structure of concrete-hard mud are so firmly attached (in some cases by their deceased inhabitants), with anchorage bore-holes reaching approximately half an inch into the mortar, that violent treatment removes not only the offending mud, but also the plaster beneath. The most effective means of removal was found to be through gradual dissolution by both spraying and poulticing with large quantities of water before gently scraping away the residue with a knife blade; but more research is necessary before a perfect method can be obtained (compare Zaky Iskander, "Bees in the Temple of Edfu and their Control," in *Annales du Service des Antiquités de l'Égypte*, vol. 58 [1964], pp. 187-96).

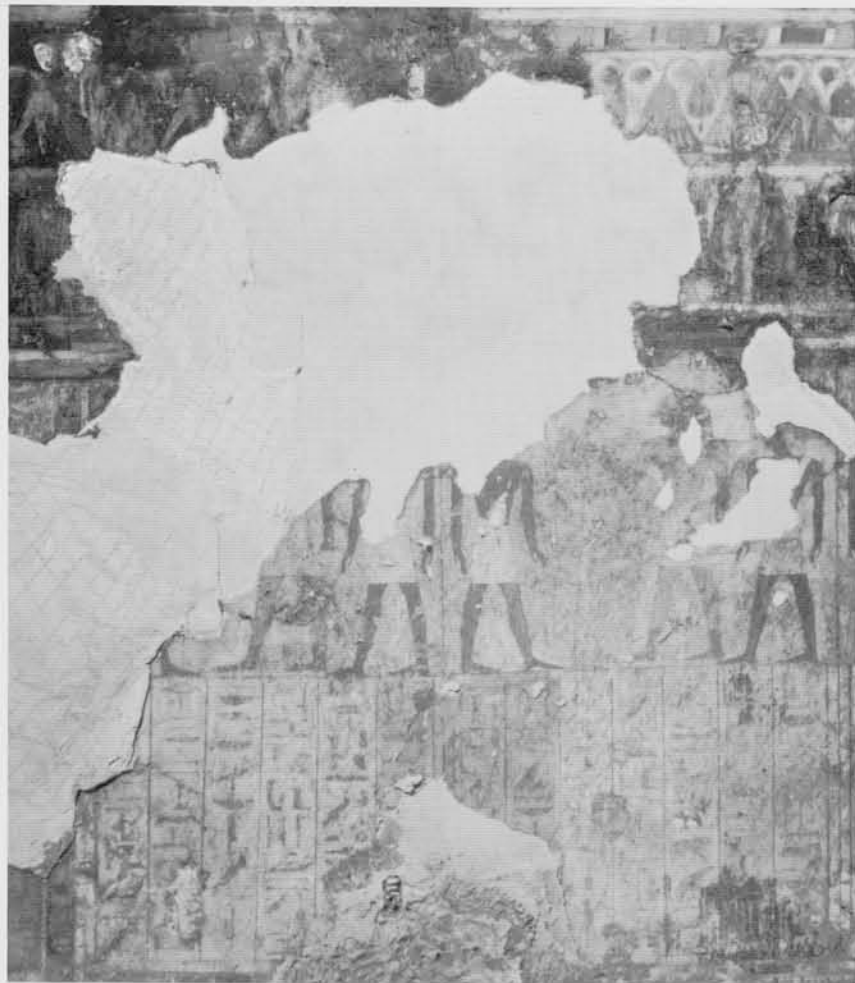
Wall in broad-hall of tomb of the High Priest Bekenkhons, after partial cleaning. Scenes and accompanying texts are surmounted by decorative bands, the black areas of which are due to irreparable damage by heat and fire. White patches represent various stages of modern replastering. In lower center are visible, consecutively, the underlying lime plaster, mud plaster, and rough-cut limestone supports of the painted surface. Cleaning of the three broken columns of inscription immediately above was delayed until consolidation by replastering could be completed.

In certain, and alas, quite substantial areas, although the carbon deposit was removed successfully, the painted plaster surface had been subjected to such intense heat that the decoration is permanently obscured by the physical and chemical changes due to actual burning.

To the great alarm of the local workers, whose concern was for the conservation of water, the sand was thoroughly washed many times, until all of the foreign matter was separated from the clean sand. Since the lime-putty and sand mixture must be applied with as little water as possible, to prevent rapid drying and therefore shrinkage, the washed sand was dried in the sun. Then it was sifted, the larger particles being separated out for the initial layer of rendering, which in proportions of approximately two parts sand to one part lime, provided a surface of sufficiently rough texture to afford a satisfactory bond for the final coat of mortar, which was prepared from the finely sifted residue, in the proportions of approximately three parts sand to two parts lime. Allowed to dry, this mortar proved to be highly stable and very strong but, because of the extreme whiteness of the lime, too light in color to blend satisfactorily with the orig-

inal. In future it will be necessary to add to the mixture a quantity of mineral colors (chemically inert) to rectify this deficiency.

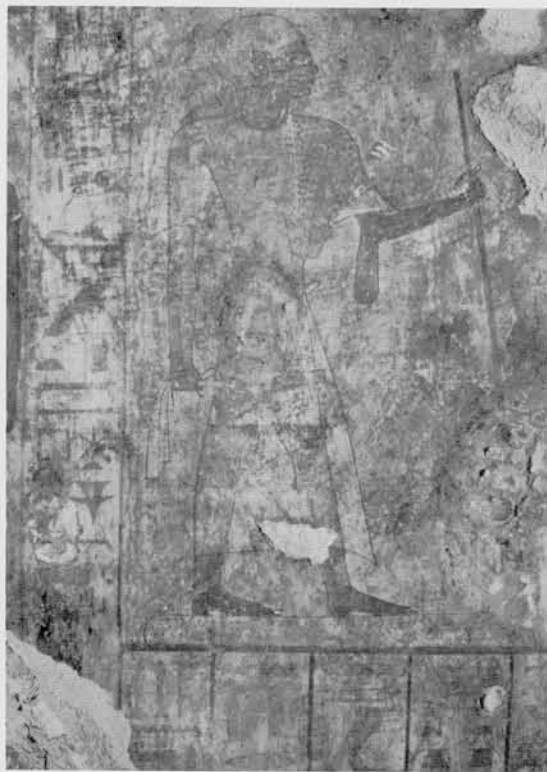
Figure of the High Priest Bekenkhons in broad-hall of his tomb. In spite of extensive damage of varying sorts, even partial cleaning reveals high quality of the ancient painting.

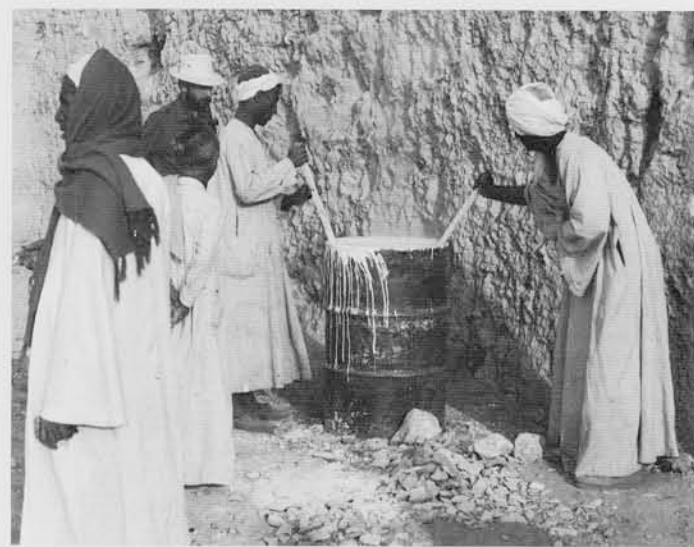
Burnt crushed lime is slaked in barrel in court of tomb of Bekenkhons. Slaked lime is to be combined with clean, sifted, sharp-grained sand to prepare new plaster.

Consequently, to prevent any such actions, the preparation of the replacement mortar was strictly controlled, using only locally obtained materials, with every precaution being exercised as to their purity. A quantity of high grade rock-lime was slaked (*i.e.*, on the site converted from limestone, by the chemical combination with water, into calcium hydroxide) and left to mature. This was subsequently combined in varying proportions with sand procured, presumably, as locally as was the original. Although very suitable for use as the aggregate, being sharp-grained, this sand proved to contain large quantities of loam, which in turn harbors the dangerous mineral salts.
