A MARVEL OF MAYA ENGINEERING

WATER MANAGEMENT AT TIKAL

BY PETER D. HARRISON

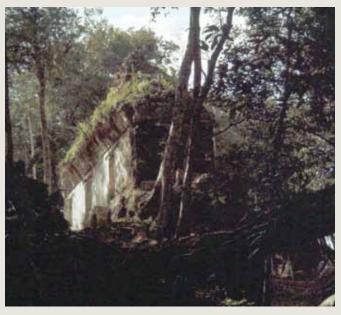
In this photograph from 1959, the palace structure is seen at the top of the staircase above the royal kitchen.

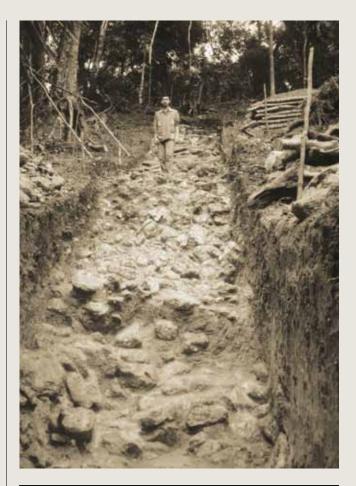
Top, Guatemalan archaeologist Jose Leva stands on the dike stairway in a 1962 photograph. Middle, a profile of the Palace Reservoir, looking north of the dike stairway, indicates three water levels. Bottom, the north-south cross-section of the Palace Reservoir illustrates bedrock indentations

The west face of the excavated dike was also revealing. A staircase was discovered running from the highest point of the dike down to the lowest level of sediment; it was constructed with three platforms: at the top, the bottom, and near the middle. These platforms coincided with notches in the bedrock cut by water farther west in the reservoir, marking levels that were sustained for long periods of time. These markers allowed a reconstruction of the size of the reservoir at the three contained water levels or capacities recognized by the Maya: the highest, the lowest, and the median. It is assumed that repeatedly eroded natural levels were created by rainfall and marked by the Maya with platforms. The uppermost level (at 237 m above sea level) was determined by the construction height of the man-made dike.

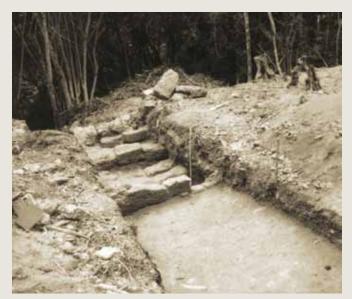
This 1962 photograph of the excavation of the kitchen foundation walls looks south. The reservoir ravine, here filled with dense vegetation, lies beyond the kitchen.

the collapse debris from the Acropolis above. This building was constructed on the platform's edge, just above the high water line of the reservoir and close to the base of two grand staircases leading to the palaces above. The two long rooms of the kitchen were divided by one wall with low masonry exterior walls, presumably intended to protect cooking fires from wind and rain. Postholes dug into the bedrock supported a pole-and-thatch structure similar to Maya kitchens today, only larger. Shape and excavation details revealed three fire pits in the north room, while the south room, closer to the water's edge, was likely used for food preparation and presentation prior to its transport via staircase to the palaces above.

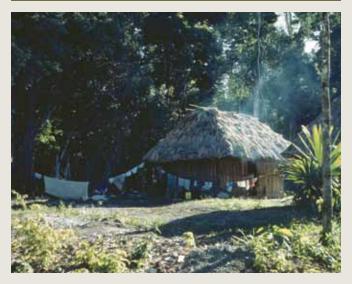
As shown in this 1959 photograph, modern Maya kitchens are built as structures separate from the residential buildings. Note the smoke emerging through the thatch roof.
