## Plants in the Service of Archaeological Preservation

by Naomi F. Miller

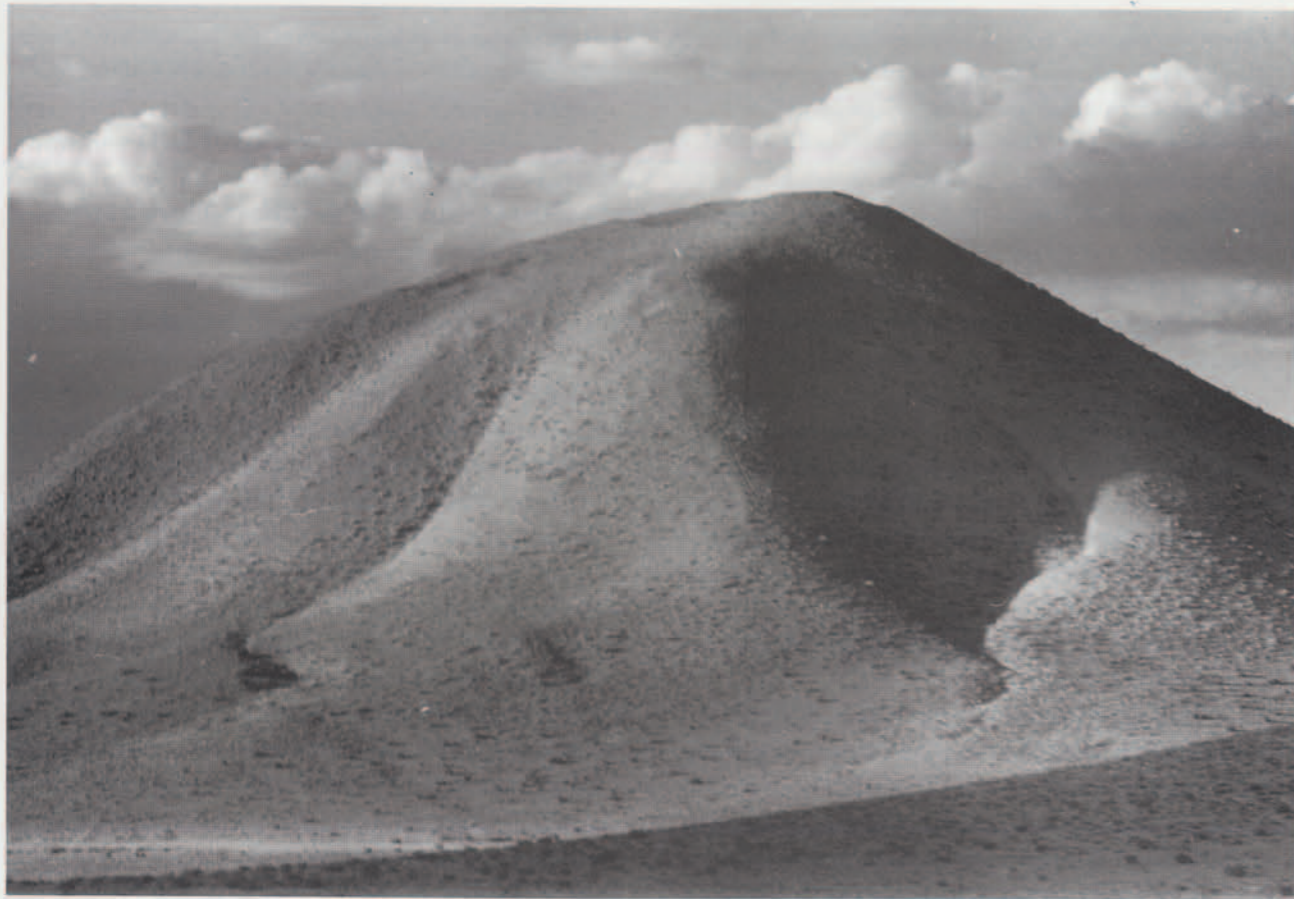
Fig. 1. It is dramatically clear from this photograph, taken in 1957, that the surface of the Midas Mound has been eroding for some time.

Several years ago Dr. İlhan Temizsoy, director of the Museum of Anatolian Civilizations, expressed concern about erosion on the Midas Mound at Gordion (Fig. 1). It occurred to me that the most effective way to reduce soil loss would be to have an uninterrupted cover of plants grow on the mound surface. At that time, the vegetation looked much like the surrounding overgrazed pasture, which is characterized by bare ground, many spiny plants, and plants that defend themselves against grazing goats and sheep

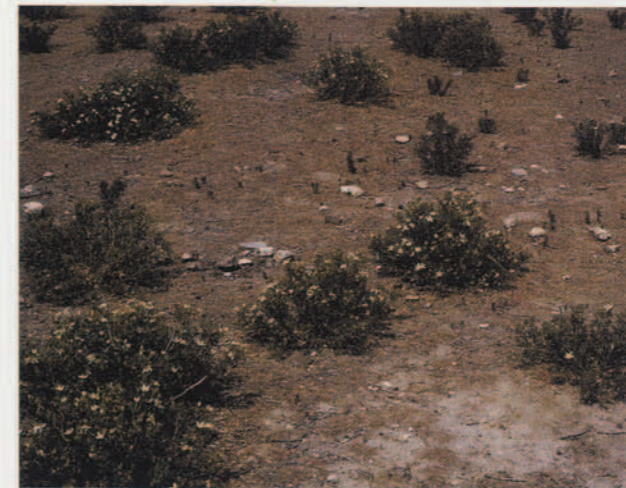
Fig. 2 (top). An overgrazed area at Gordion shows patches of *Peganum harmala* (wild rue). The flocks avoid *Peganum*, because the leaves contain a bitter alkaloid (harmaline), but have eaten almost everything growing between the plants.

by producing bitter compounds in their leaves (Fig. 2). I also began to envision an even grander project—recovery or partial restoration of the vegetation native to this part of Turkey. The central Anatolian steppe grassland is highly diverse, and includes many perennial grasses, wildflowers, and small shrubs that stay green all or most of the year and that are palatable to grazers (Fig. 3). Restored vegetation would not only be beautiful, but would also improve the rangeland.

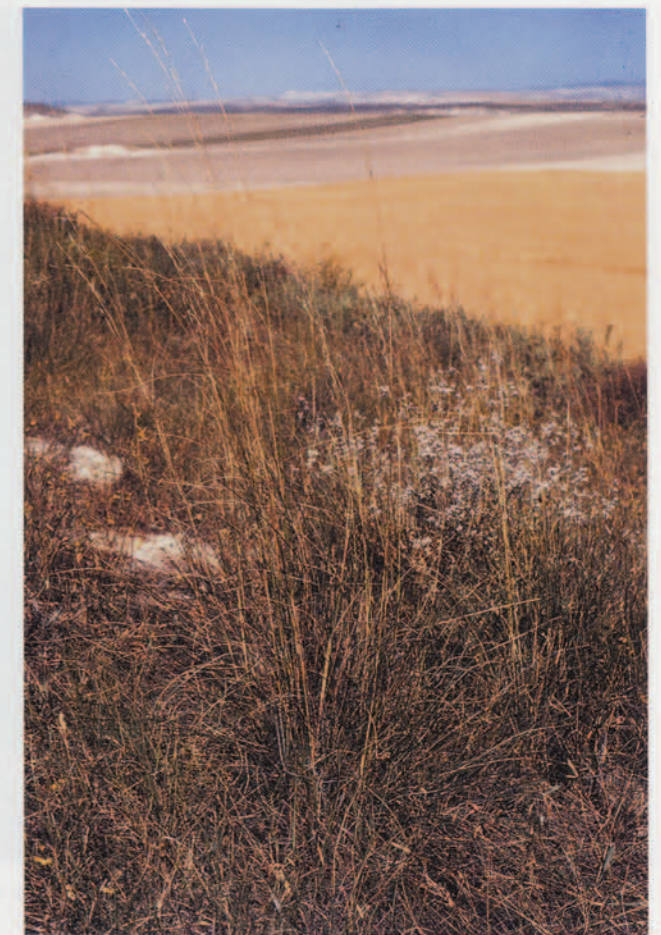
Fig. 3 (right). The inspiration for the Midas Mound conservation and revegetation project came after a visit to this small patch of (then) relatively undisturbed grassy steppe. Surrounded by dry-farmed fields and lying about 5 kilometers from the nearest village, the naturally high diversity of plants was able to grow here.

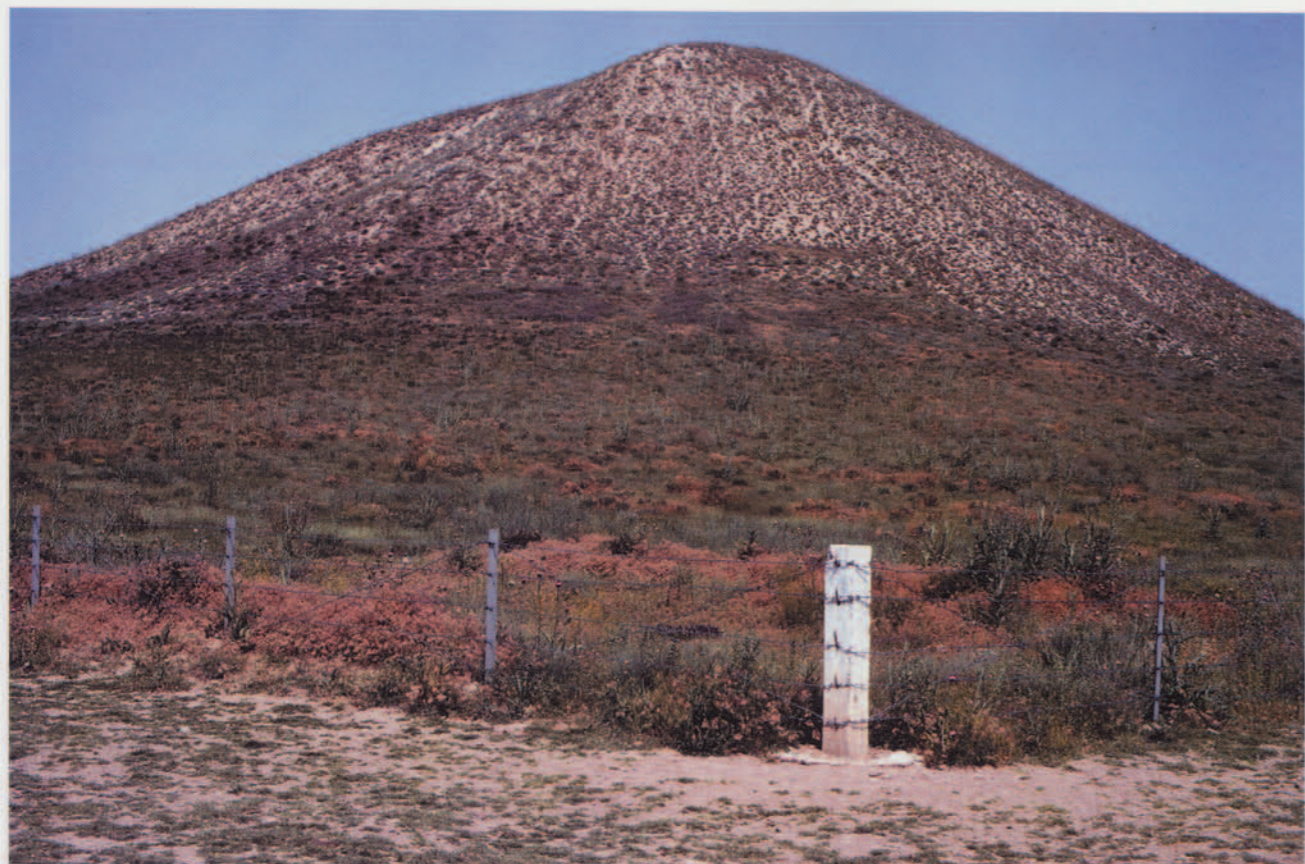
Fig. 4. Protected by the fence, it has not taken long for plants to spread onto the base of the mound. Outside the fence, the flocks still pass by and plant cover is sparse.

Following the concept, "first do no harm," it seemed best initially just to encourage the existing plant cover to spread; thus, in April 1996 the General Directorate of Monuments and Museums erected a fence to keep animals and people off the mound (Fig. 4). By the summer of 1997, a luxuriant cover of grasses and other plants on the lower slopes demonstrated that the fence had begun to work at the base of the mound. Further

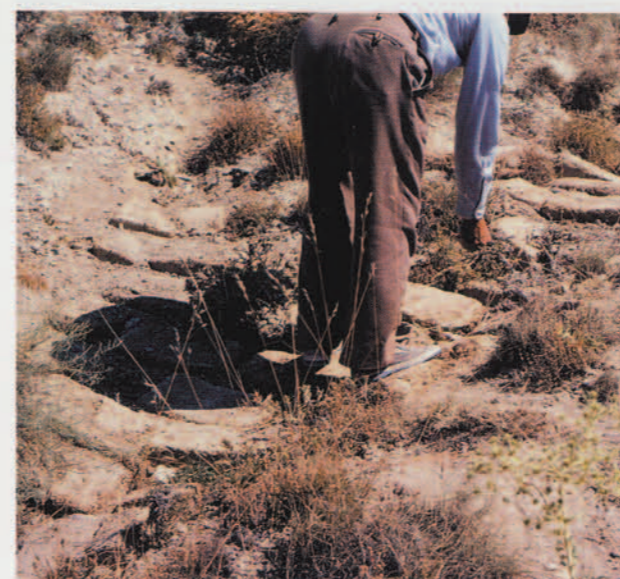
Fig. 5 (top left). Remzi Yilmaz sprinkling seeds between the bricks in one of the erosion channels. The bricks are laid across the channel in rows about 5 cm apart. Although several types of seeds were planted, only annual grasses survived.

The Gordion Project arranged to have 1000 mudbricks from a dismantled village structure placed in two of the erosion channels. The Gordion site caretaker, Remzi Yilmaz, was drafted to supervise the laying of bricks in the fall of 1997 (Figs. 5, 6). The work had to be done by hand because heavy equipment would destroy the soft surface of the mound. As I described the plan to Remzi, the watchman for the dig house listened in. I explained that it was just an "experiment"; if it did not work out, I didn't want Remzi to blame himself. But then I caught the eye of the watchman. "You think I'm crazy, don't you?" I asked him; he smiled and said, "Well, if it works, you're not crazy."

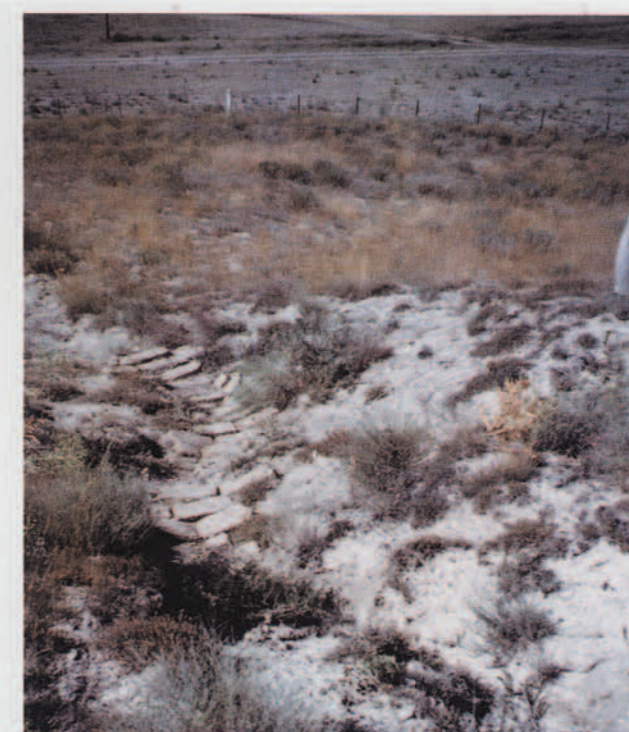
Fig. 6 (top right). Looking downhill after some of the mudbrick was laid in 1997.

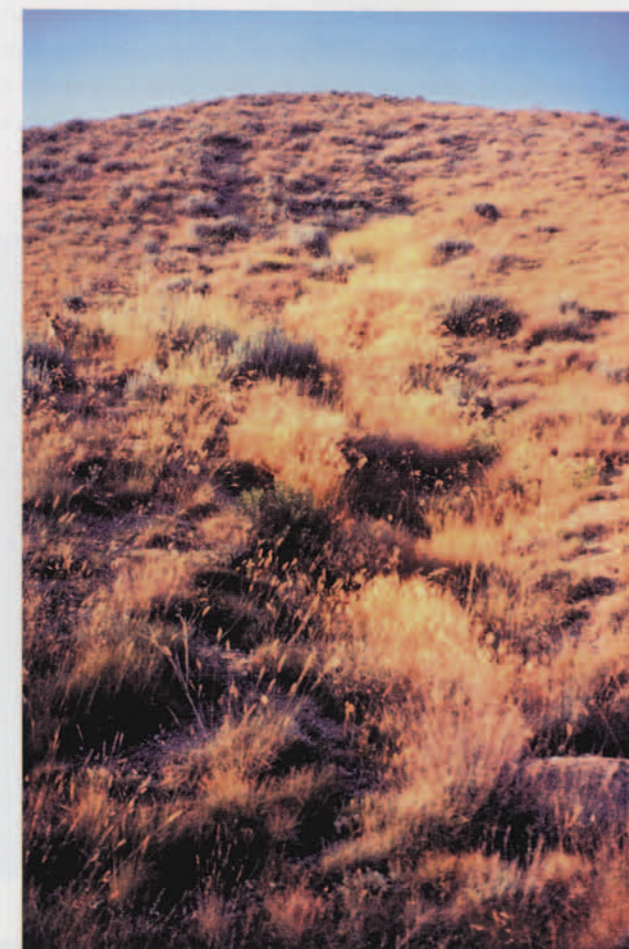
Fig. 7 (right). After two growing seasons, the annual grasses continue to thrive in the bed of the erosion channel. Even better, some of the perennial grasses and other plants that grow on the mound have been able to take advantage of the stabilized soil surface and have spread to the channel.

By the spring of 1998, plants were thriving in both channels where the bricks had been laid (Fig. 7), and I have counted and mapped over 125 different types of plants, distributed according to their own growth requirements (Fig. 8).

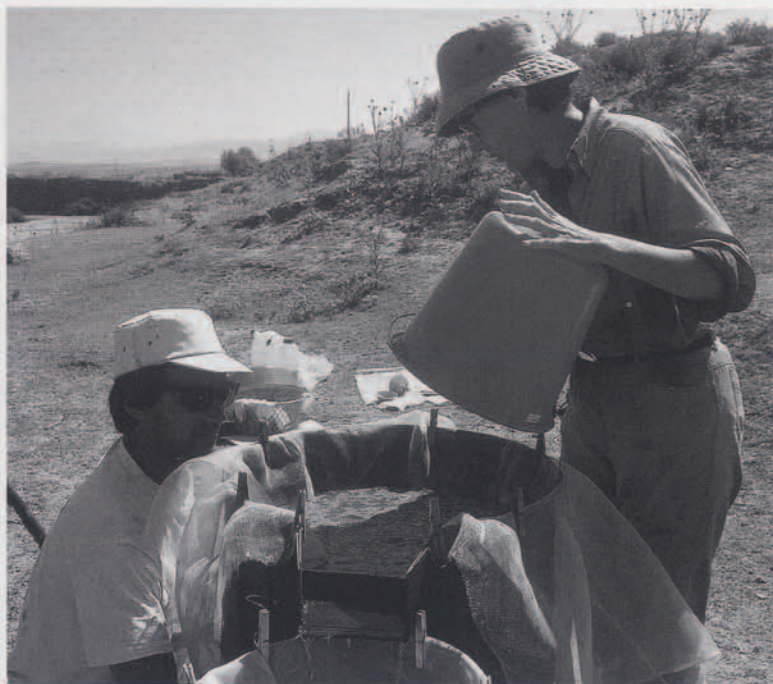
At Gordion, we used a pump-driven flotation device to extract and concentrate the tiny bits of charred seeds and wood from samples of the archaeological deposits. Here I am pouring a bucket of dirt into the tank while my assistant adjusts the water level. As the water flows up and out of the tank, charred seeds and wood bits are caught in a cloth. After they dry, they are examined at low-magnification under a light microscope. Changes through time in the proportions of different types help us interpret corresponding changes in ancient vegetation and land use.

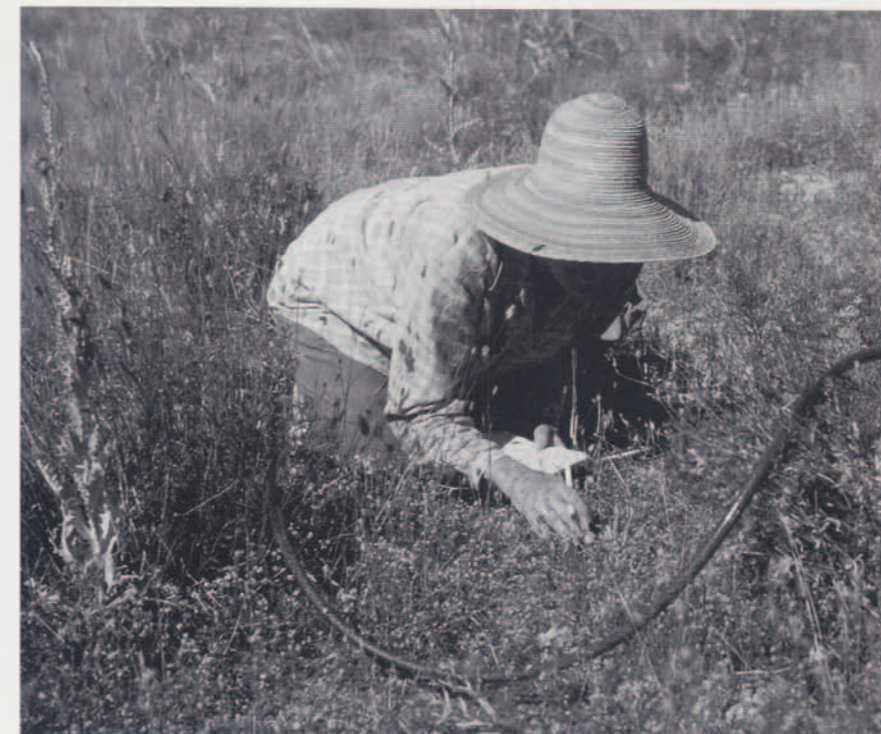
Fig. 8. Part of our conservation efforts involves gathering information as the project evolves. Here, I am in the midst of censusing plants on the Midas Tumulus; every 10 meters along a transect, I identify all the plant types growing in one square meter (the area encircled by the 3.54 m length of garden hose).

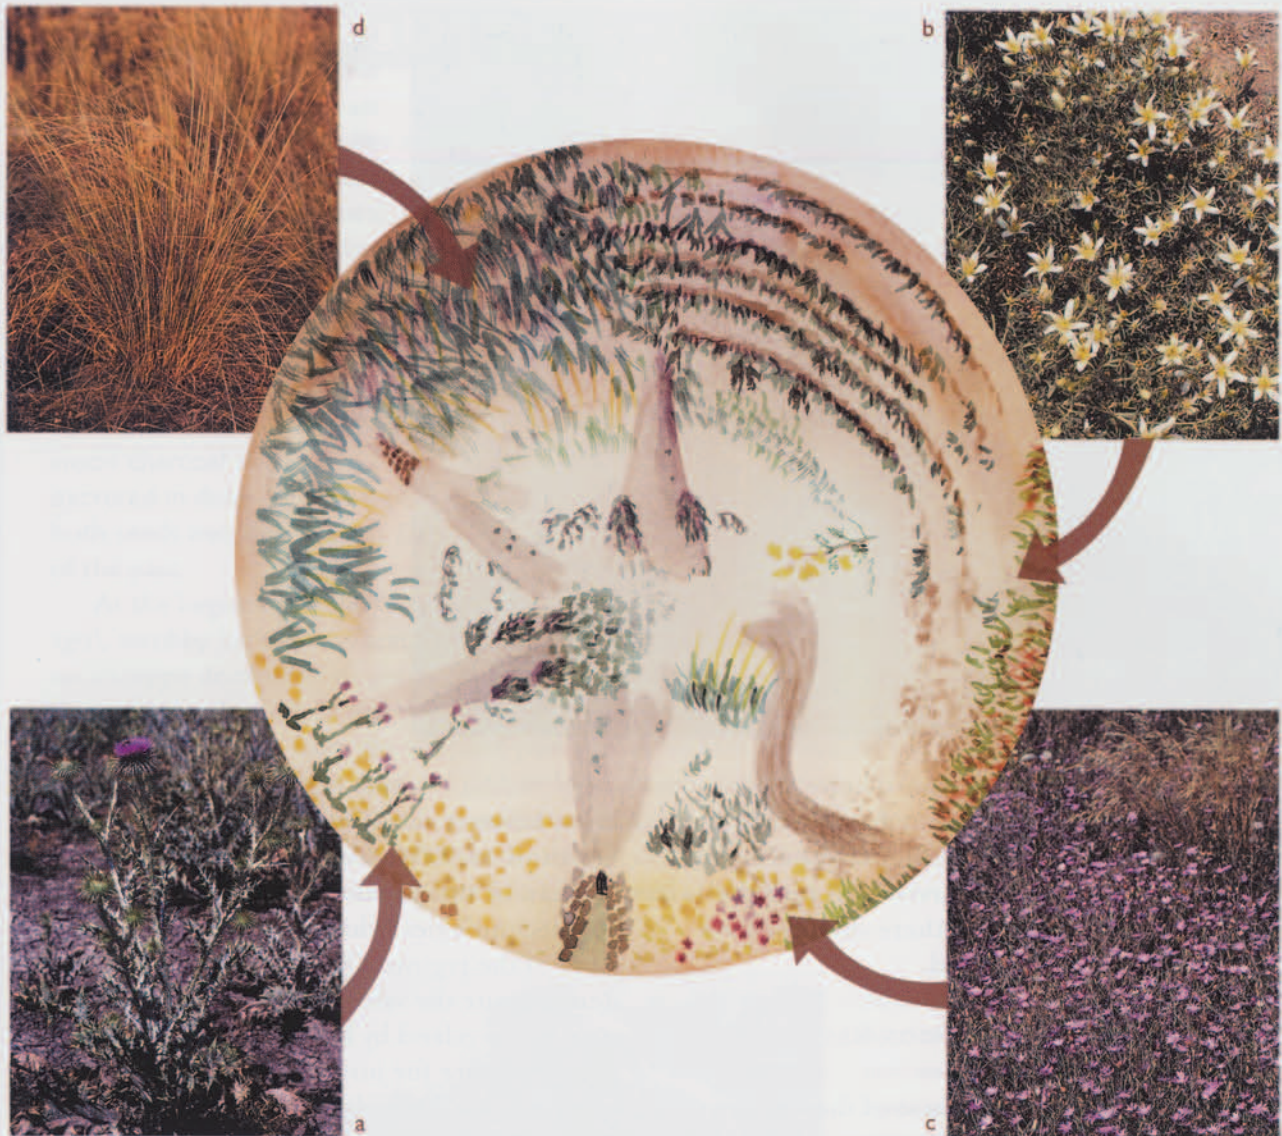
Fig. 9. Schematic watercolor of prominent vegetation on the mound as if seen from the air as we began the experiment with the bricks. Note that plant distribution varies according to slope and aspect. Thistles (probably *Onopordum* sp.; see 'a') thrive on the lower southwest slope and wild rue (*Peganum harmala*; 'b') continues to grow profusely on the southeast side of the mound along one of the main paths to the village from the surrounding pastureland. A small member of the daisy family (*Xeranthemum inapertum*; 'c') grows toward the base on the south side. Wormwood (*Artemisia* sp.), so common but nondescript that I did not think to paint it, is relatively sparse only in the northeast sector. The painting also illustrates trails beaten through the wild thyme by sheep in years past on the northeast side, and perennial grasses thriving on the north side. One of these grasses, *Stipa holosericea* ('d'), is an important part of the native steppe vegetation of central Anatolia and makes a fine fodder.

The mapping demonstrates that there is no one plant or even group of plants that is best for the mound (Fig. 9). For example, one perennial grass, *Stipa arabica*, does very well in the southeast sector, while another one, *Bromus cappadocicus*, is most abundant in the north sector.
